U.S.-Canada Power System Outage Task Force

Interim Report:  
Causes of the  
August 14th Blackout  
in the  
United States and Canada

November 2003

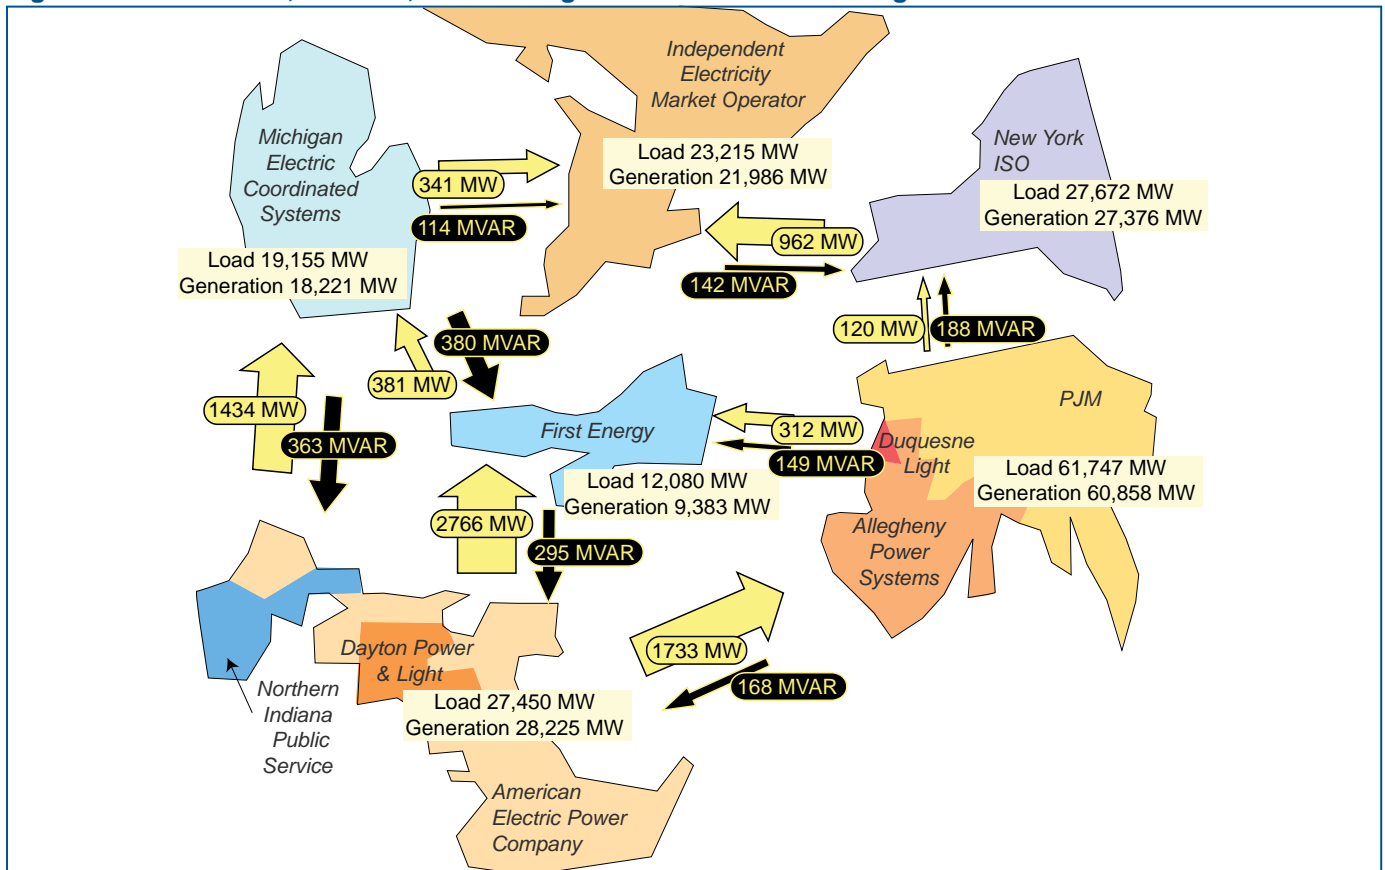
**Figure 3.2. Generation, Demand, and Interregional Power Flows on August 14 at 15:05 EDT**

The power flow data for northern Ohio on August 14 just before the Harding-Chamberlin line tripped at 15:05 EDT (Figure 3.2) show that FE's load was approximately 12,080 MW. FE was importing about 2,575 MW, 21% of its total system needs, and generating the remainder. With this high level of imports and high air conditioning loads in the

metropolitan areas around the southern end of Lake Erie, FE's system reactive power needs rose further. Investigation team modeling indicates that at 15:00 EDT, with Eastlake 5 out of service, FE was a net importer of about 132 MVar. A significant amount of power also was flowing through northern Ohio on its way to Michigan and Ontario (Figure 3.2). The net effect of this flow pattern and load composition was to depress voltages in northern Ohio.

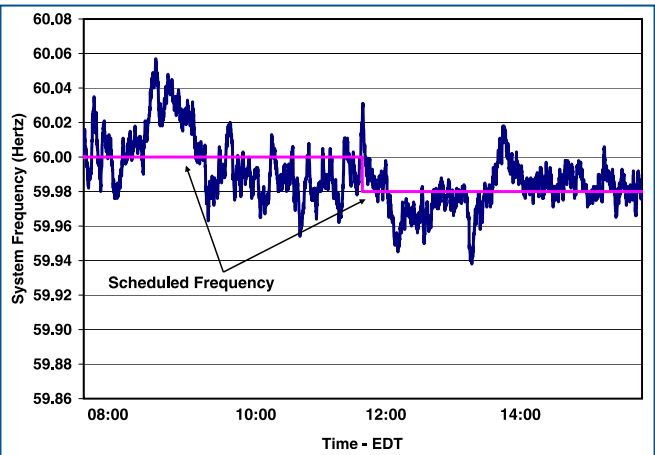
**Figure 3.4. Frequency on August 14, 2003, up to 15:31 EDT**

August 14 prior to 15:05 EDT compared with recent history, it was well within the bounds of safe operating practices as outlined in NERC operating policies. As a result, system frequency variation was not a cause of the initiation of the blackout. But once the cascade was initiated, the large frequency swings that were induced became

a principal means by which the blackout spread across a wide area (Figure 3.4).

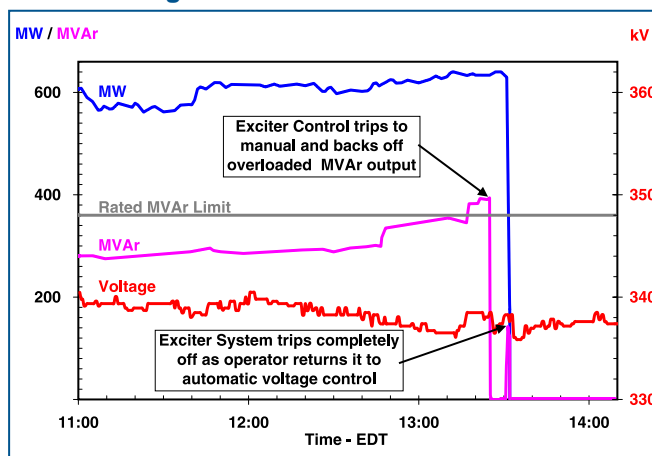
**Figure 3.5. MW and MVar Output from Eastlake Unit 5 on August 14**

output (Figure 3.5), the unit's protection system detected a failure and tripped the unit off-line. The loss of the Eastlake 5 unit did not put the grid into an unreliable state—i.e., it was still able to withstand safely another contingency. However, the loss of the unit required FE to import additional power to make up for the loss of the unit's output (540 MW), made voltage management in northern Ohio more challenging, and gave FE operators less flexibility in operating their system (see details below, page 27).

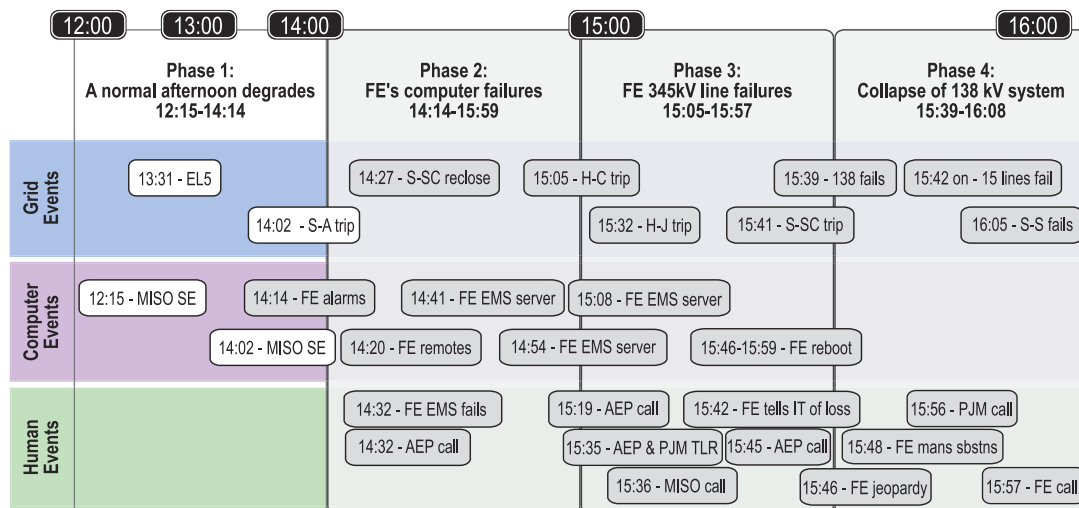
**Figure 4.2. Timeline Phase 1**

The FE reliability operator was concerned about low voltage conditions on the FE system as early as 13:13 EDT. He asked for voltage support (i.e., increased reactive power output) from FE's

interconnected generators. Plants were operating in automatic voltage control mode (reacting to system voltage conditions and needs rather than constant reactive power output). As directed in FE's Manual of Operations,<sup>4</sup> the FE reliability operator began to call plant operators to ask for additional voltage support from their units. He noted to most of them that system voltages were sagging "all over." Several mentioned that they were already at or near their reactive output limits. None were asked to reduce their active power output to be able to produce more reactive output. He called the Sammis plant at 13:13 EDT, West Lorain at 13:15 EDT, Eastlake at 13:16 EDT, made three calls to unidentified plants between 13:20 EDT and 13:23 EDT, a "Unit 9" at 13:24 EDT, and two more at 13:26 EDT and 13:28 EDT.<sup>5</sup> The operators worked to get shunt capacitors at Avon that were out of service restored to support voltage.<sup>6</sup>

Following the loss of Eastlake 5 at 13:31 EDT, FE's operators' concern about voltage levels was heightened. They called Bayshore at 13:41 EDT and Perry at 13:43 EDT to ask the plants for more voltage support. Again, while there was substantial effort to support voltages in the Ohio area, First Energy personnel characterized the conditions as not being unusual for a peak load day, although this was not an all-time (or record) peak load day.

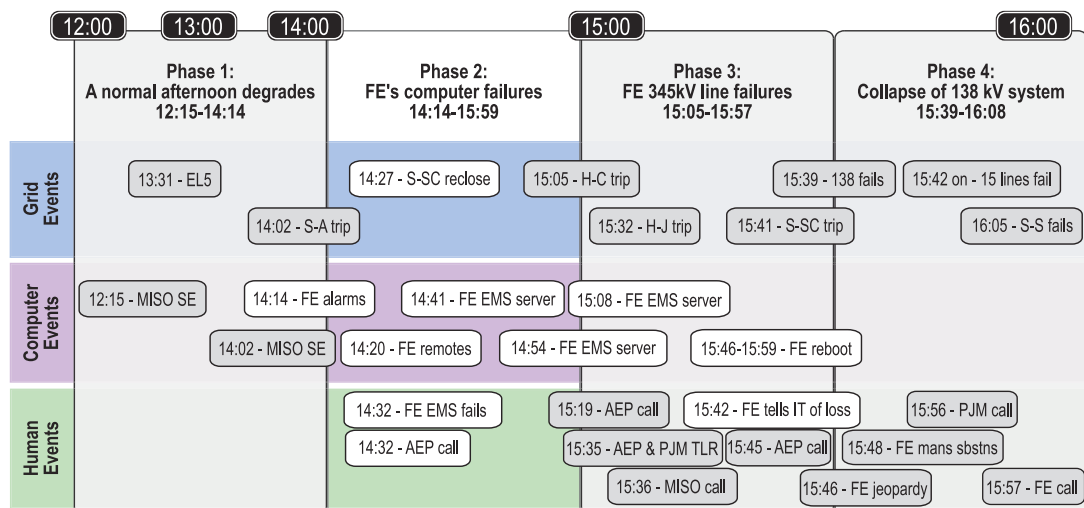
**Figure 4.4. Timeline Phase 2**

- 2A) 14:14 EDT: FE alarm and logging software failed. Neither FE's control room operators nor FE's IT EMS support personnel were aware of the alarm failure.
- 2B) 14:20 EDT: Several FE remote location consoles failed. FE Information Technology (IT) engineer was computer auto-paged.
- 2C) 14:27:16 EDT: Star-South Canton 345-kV transmission line tripped and successfully reclosed.
- 2D) 14:32 EDT: AEP called FE control room about AEP indication of Star-South Canton 345-kV line trip and reclosure. FE had no alarm or log of this line trip.
- 2E) 14:41 EDT: The primary FE control system server hosting the alarm function failed. Its applications and functions were passed over to a backup computer. FE's IT engineer was auto-paged.

2F) 14:54 EDT: The FE back-up computer failed and all functions that were running on it stopped. FE's IT engineer was auto-paged.

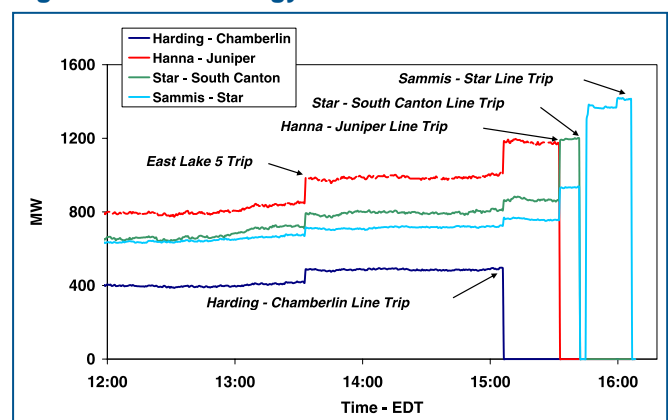
**Figure 4.5. FirstEnergy 345-kV Line Flows**

From 15:05:41 EDT to 15:41:35 EDT, three 345-kV lines failed with power flows at or below each transmission line's emergency rating. Each was the result of a contact between a line and a tree that had grown so tall that, over a period of years, it encroached into the required clearance height for the line. As each line failed, its outage increased the loading on the remaining lines (Figure 4.5). As each of the transmission lines failed, and power flows shifted to other transmission paths, voltages on the rest of FE's system degraded further (Figure 4.6).

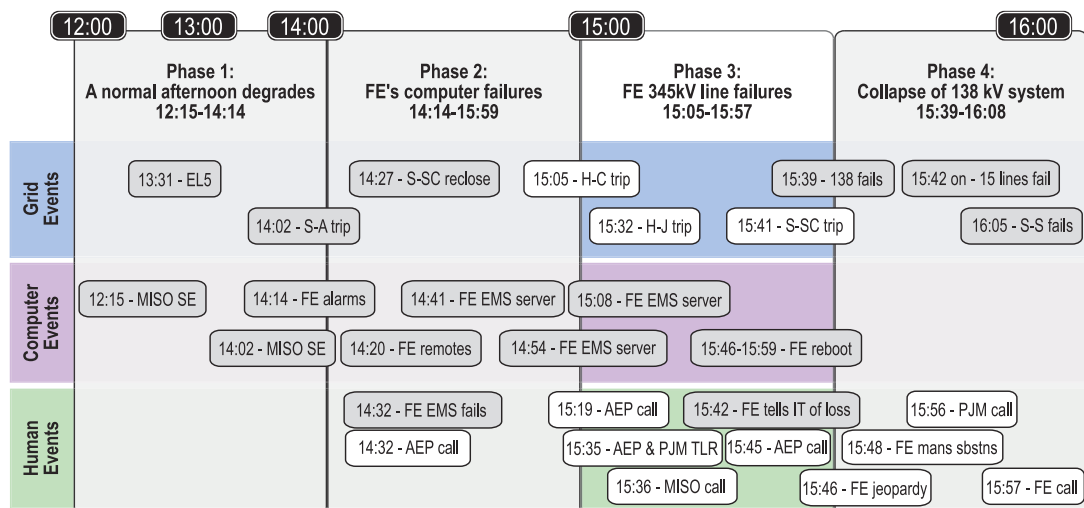
**Figure 4.7. Timeline Phase 3**

- 3A) 15:05:41 EDT: Harding-Chamberlin 345-kV line tripped.
- 3B) 15:31-33 EDT: MISO called PJM to determine if PJM had seen the Stuart-Atlanta 345-kV line outage. PJM confirmed Stuart-Atlanta was out.

- 3C) 15:32:03 EDT: Hanna-Juniper 345-kV line tripped.
- 3D) 15:35 EDT: AEP asked PJM to begin work on a 350-MW TLR to relieve overloading on the Star-South Canton line, not knowing the Hanna-Juniper 345-kV line had already tripped at 15:32 EDT.
- 3E) 15:36 EDT: MISO called FE regarding post-contingency overload on Star-Juniper 345-kV line for the contingency loss of the Hanna-Juniper 345-kV line, unaware at the start of the call that Hanna-Juniper had already tripped.
- 3F) 15:41:33-41 EDT: Star-South Canton 345-kV tripped, reclosed, tripped again at 15:41 EDT and remained out of service, all while AEP and PJM were discussing TLR relief options (event 3D).

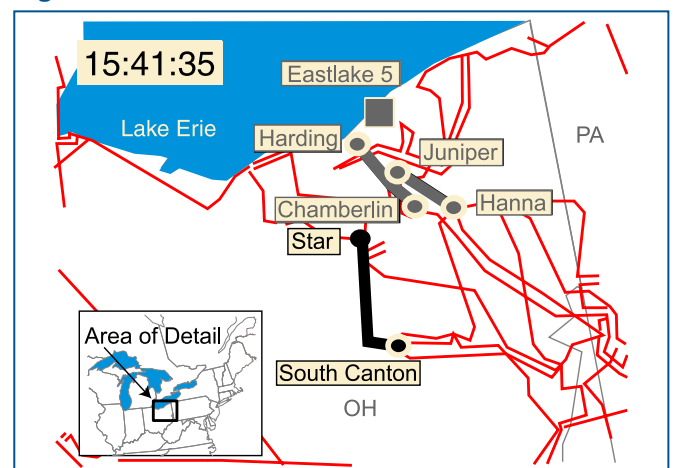
**Figure 4.11. Star-South Canton 345-kV Line**

The Star-South Canton line (Figure 4.11) crosses the boundary between FE and AEP, and the line is jointly owned—each company owns the portion of the line within its respective territory and manages the right-of-way there. The Star-South Canton line tripped and reclosed three times on the afternoon of August 14, first at 14:27:15 EDT (reclosing at both ends), then at 15:38:48 EDT, and at 15:41:35 EDT it tripped and locked out at the Star substation. A short-circuit to ground occurred in each case. This line failed with power flow at 93.2% of its emergency rating.

**System impacts of the 345-kV failures.** The investigation modeling team examined the impact of the loss of the Harding-Chamberlin, Hanna-Juniper and Star-South Canton 345-kV lines. After conducting a variety of scenario analyses, they concluded that had either Hanna-Juniper or Harding-Chamberlin been restored and remained in-service, the Star-South Canton line might not have tripped and locked out at 15:42 EDT.

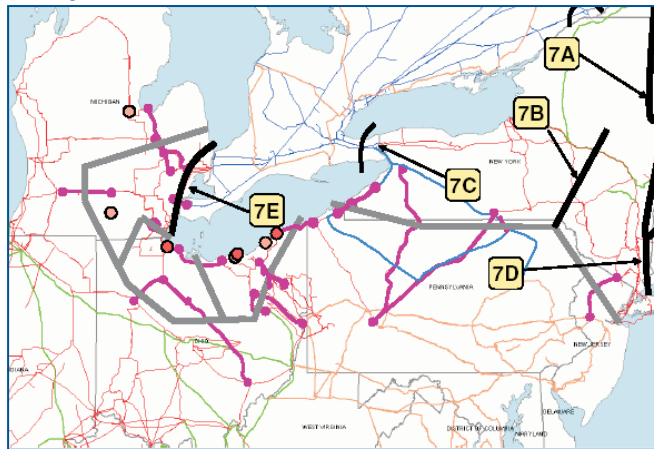
**Figure 5.13. New York and New England Separate, Multiple Islands Form**

New England (except southwestern Connecticut) and the Maritimes separated from New York and remained intact; New York split east to west: 16:10:46 EDT to 16:11:57 EDT. Figure 5.13 illustrates the events of this phase.

At 16:10:50 EDT, Ontario and New York separated west of the Ontario/New York interconnection, due to relay operations which disconnected nine 230-kV lines within Ontario. These left most of Ontario isolated to the north. Ontario's large Beck and Saunders hydro stations, along with some Ontario load, the New York Power Authority's (NYPA) Niagara and St. Lawrence hydro stations, and NYPA's 765-kV AC interconnection with Québec, remained connected to the western New York system, supporting the demand in upstate New York.

From 16:10:49 EDT to 16:10:50 EDT, frequency declined below 59.3 Hz, initiating automatic under-frequency load-shedding in Ontario (2,500 MW), eastern New York and southwestern Connecticut. This load-shedding dropped off about 20% of the load across the eastern New York island and about 10% of Ontario's remaining load. Between 16:10:50 EDT and 16:10:56 EDT, the isolation of the southern Ontario hydro units onto the western New York island, coupled with under-frequency load-shedding in the western New York island, caused the frequency in this island to rise to 63.0 Hz due to excess generation.

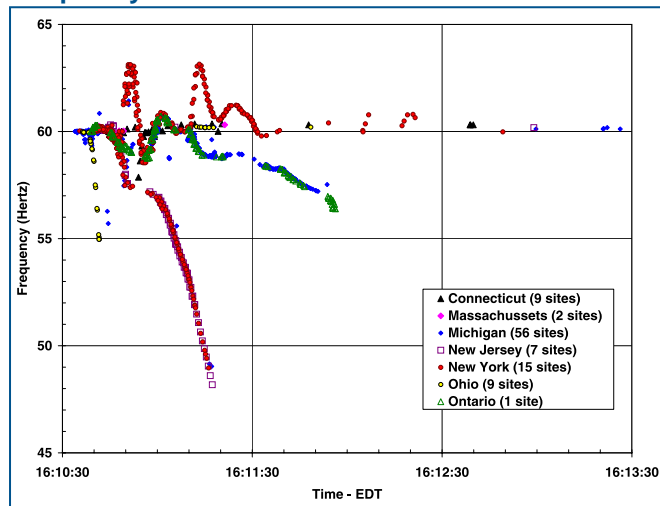
**Figure 5.14. Electric Islands Reflected in Frequency Plot**

Figure 5.14 shows frequency data collected by the distribution-level monitors of Softswitching Technologies, Inc. (a commercial power quality company serving industrial customers) for the area affected by the blackout. The data reveal at least five separate electrical islands in the Northeast as the cascade progressed. The two paths of red diamonds on the frequency scale reflect the Albany area island (upper path) versus the New York city island, which declined and blacked out much earlier.

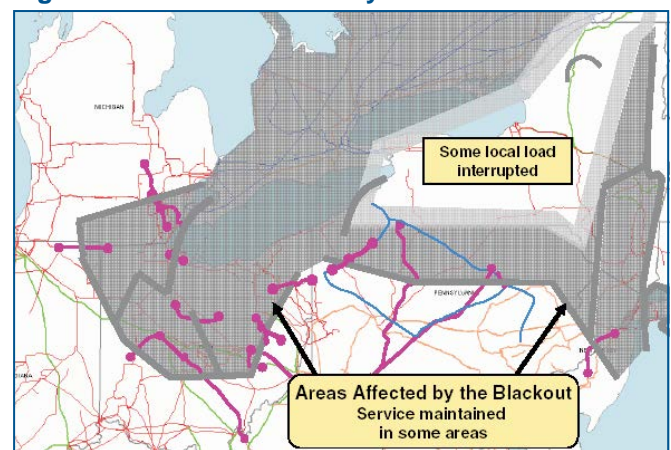
**Figure 5.15. Area Affected by the Blackout**

Most of the Northeast (the area shown in gray in Figure 5.15) was now blacked out. Some isolated areas of generation and load remained on-line for several minutes. Some of those areas in which a close generation-demand balance could be maintained remained operational; other generators ultimately tripped off line and the areas they served were blacked out.

One relatively large island remained in operation serving about 5,700 MW of demand, mostly in western New York. Ontario's large Beck and Saunders hydro stations, along with some Ontario load, the New York Power Authority's (NYPA) Niagara and St. Lawrence hydro stations, and NYPA's 765-kV AC interconnection with Québec, remained connected to the western New York system, supporting demand in upstate New York. This island formed the basis for restoration in both New York and Ontario.

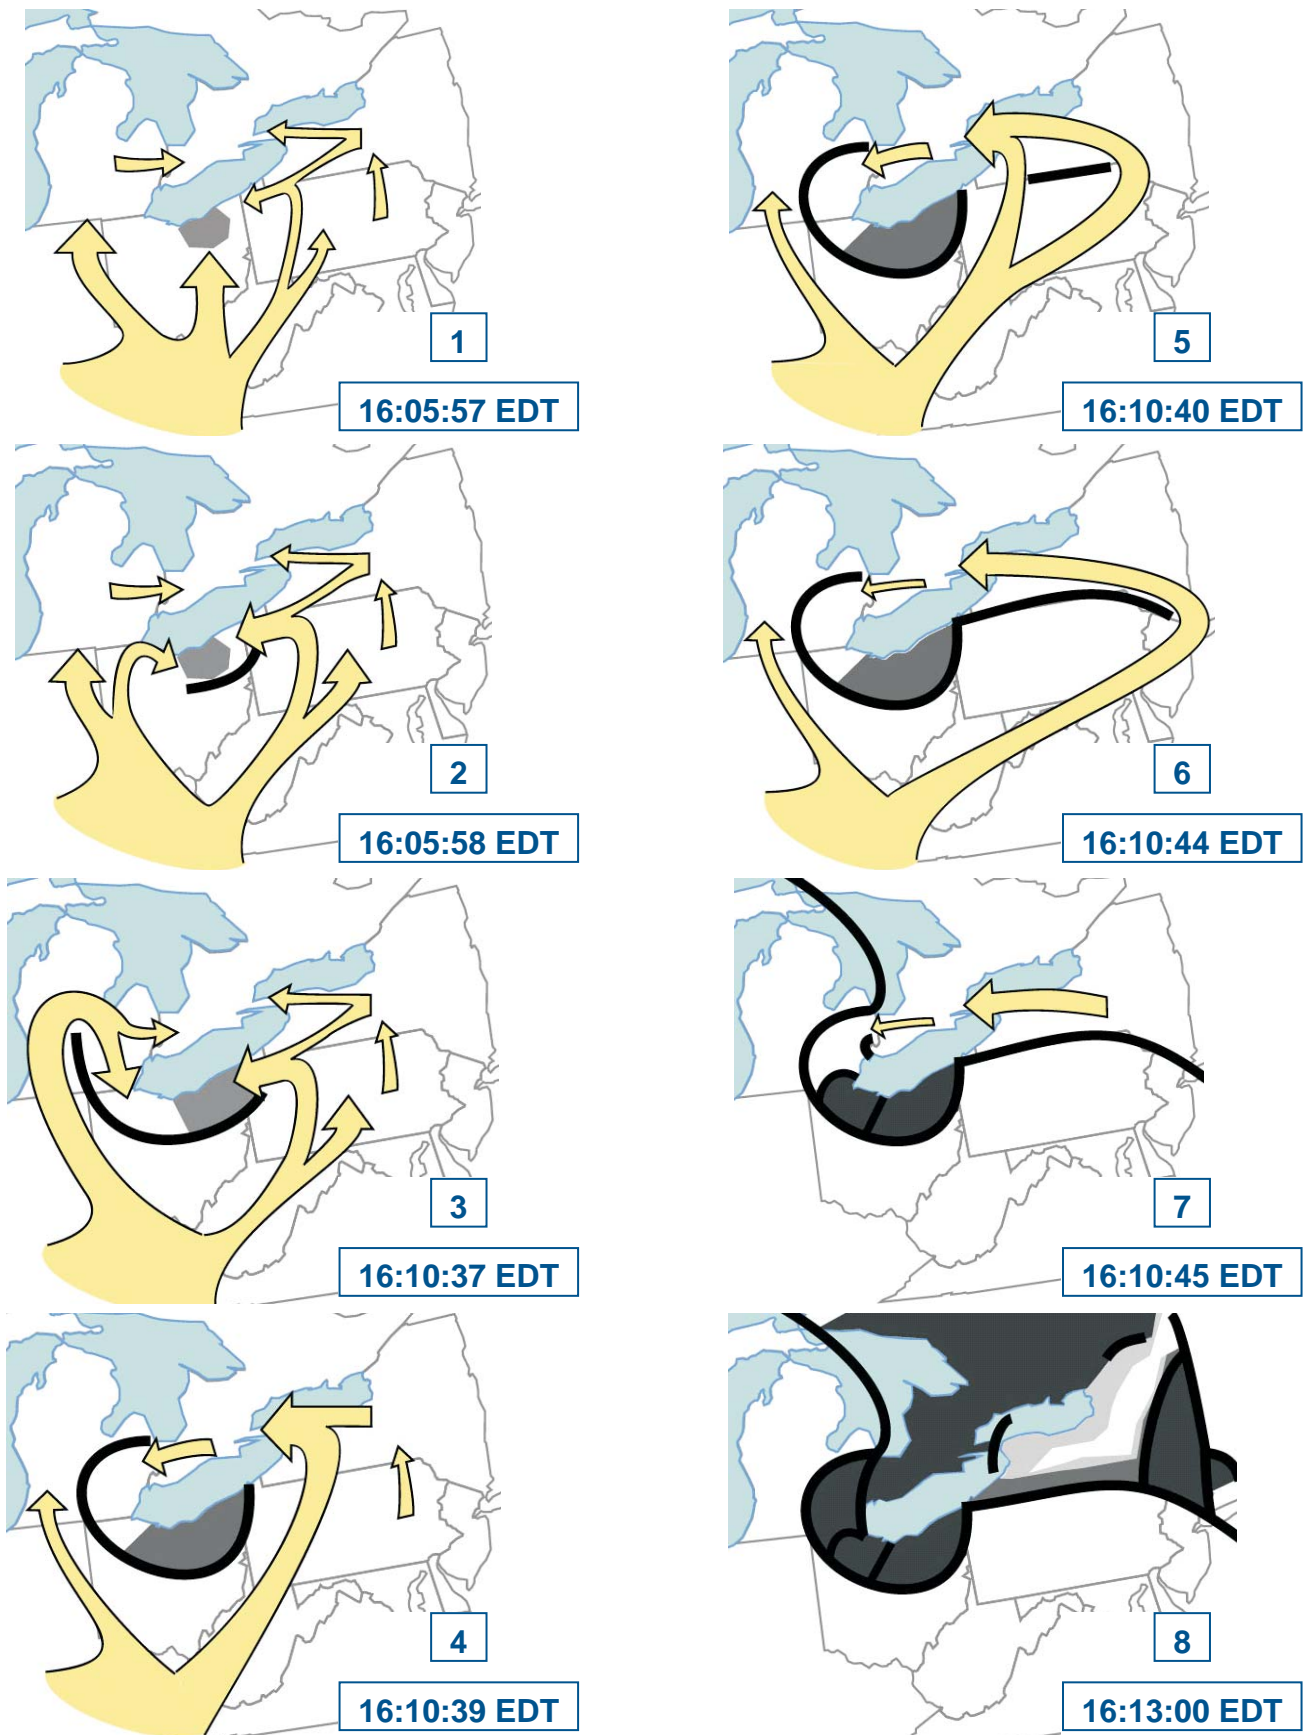
**Figure 5.16. Cascade Sequence**

The entire cascade sequence is depicted graphically in Figure 5.16 on the following page.

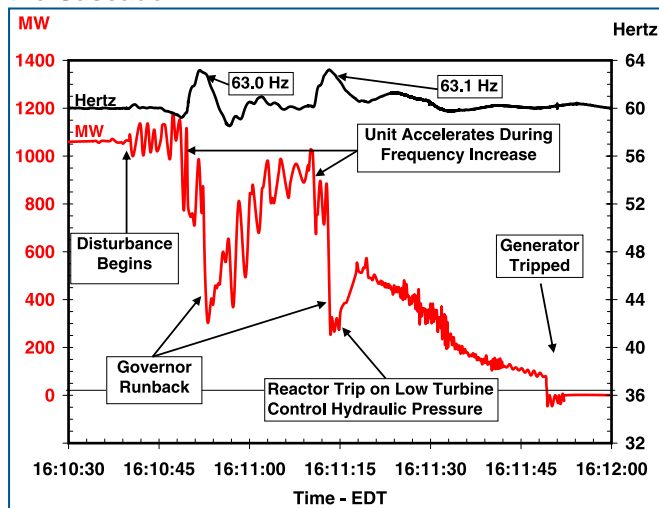
**Figure 5.17. Events at One Large Generator During the Cascade**

After the cascade was initiated, huge power swings across the torn transmission system and excursions of system frequency put all the units in their path through a sequence of major disturbances that shocked several units into tripping. Plant controls had actuated fast governor action on several of these to turn back the throttle, then turn it forward, only to turn it back again as some frequencies changed several times by as much as 3 Hz (about 100 times normal). Figure 5.17 is a plot of the MW output and frequency for one large unit that nearly survived the disruption but tripped when in-plant hydraulic control pressure limits were eventually violated. After the plant control system called for shutdown, the turbine control valves closed and the generator electrical output ramped down to a preset value before the field excitation tripped and the generator breakers opened to disconnect the unit from the system.

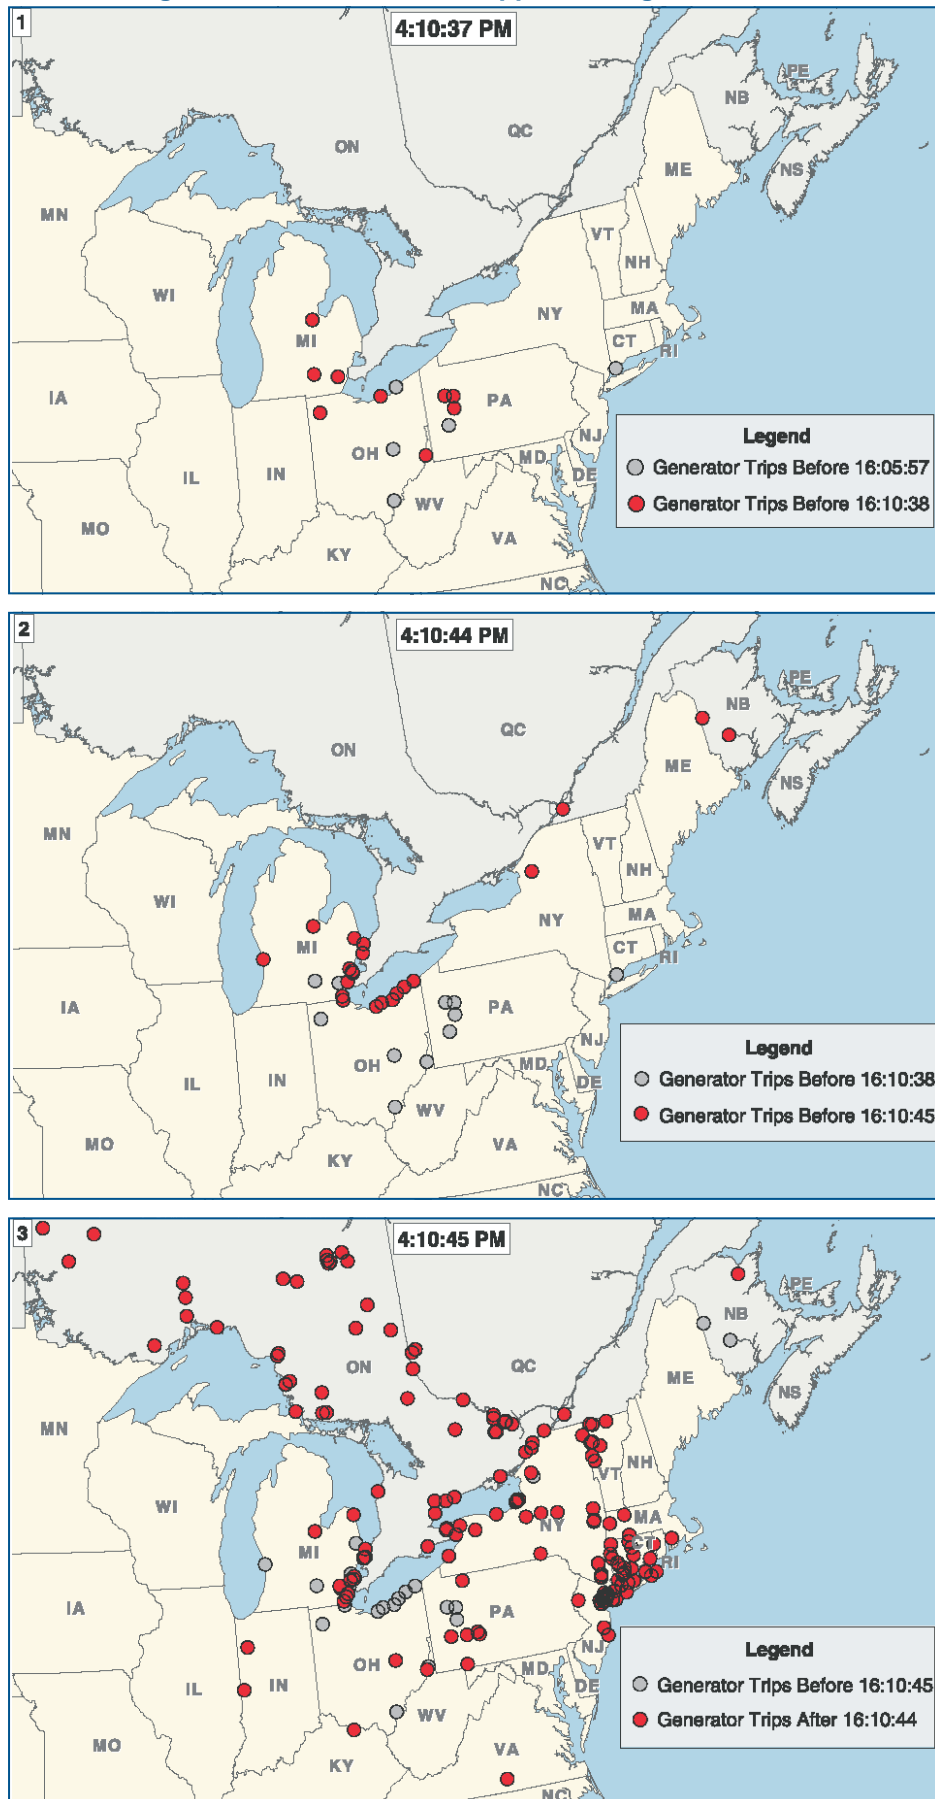
**Figure 5.18. Power Plants Tripped During the Cascade**

The maps in Figure 5.18 show the sequence of power plants lost in three blocks of time during the cascade.
